# Yellow Gas Piping in Your Home May Pose a Safety Risk

**DOVER, DE** – The Delaware Department of Insurance, the National Association of Insurance Commissioners (NAIC) and the National Association of State Fire Marshals (NASFM) are teaming up to educate homeowners on a potential safety risk involving yellow flexible gas piping. The gas piping is known as corrugated stainless steel tubing, or “yellow CSST.”

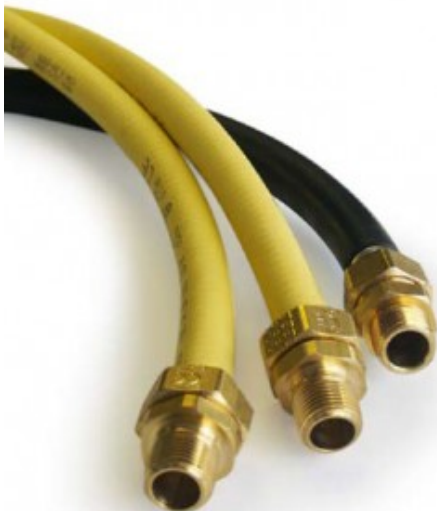
### Examples of CSST

Examples of various CSST piping, which is most often covered with a yellow plastic or rubber casing. Some CSST comes with black casing.

If you find CSST after inspecting your home or business, it is strongly recommended that you determine if the CSST system is properly bonded and grounded. A bonding device should be installed on your natural gas system in order to reduce the chances of a natural gas leak or fire. Bonding is provided primarily to prevent a possible electric shock to people who come in contact with the gas piping and other metal objects

connected to the grounding system. Nearby lightning strikes can also result in an electrical surge and can potentially puncture a hole in the CSST.
